How will we recognize, assess,
manage and improve
watershed integrity?

Water and hydrologic
information leading to findings

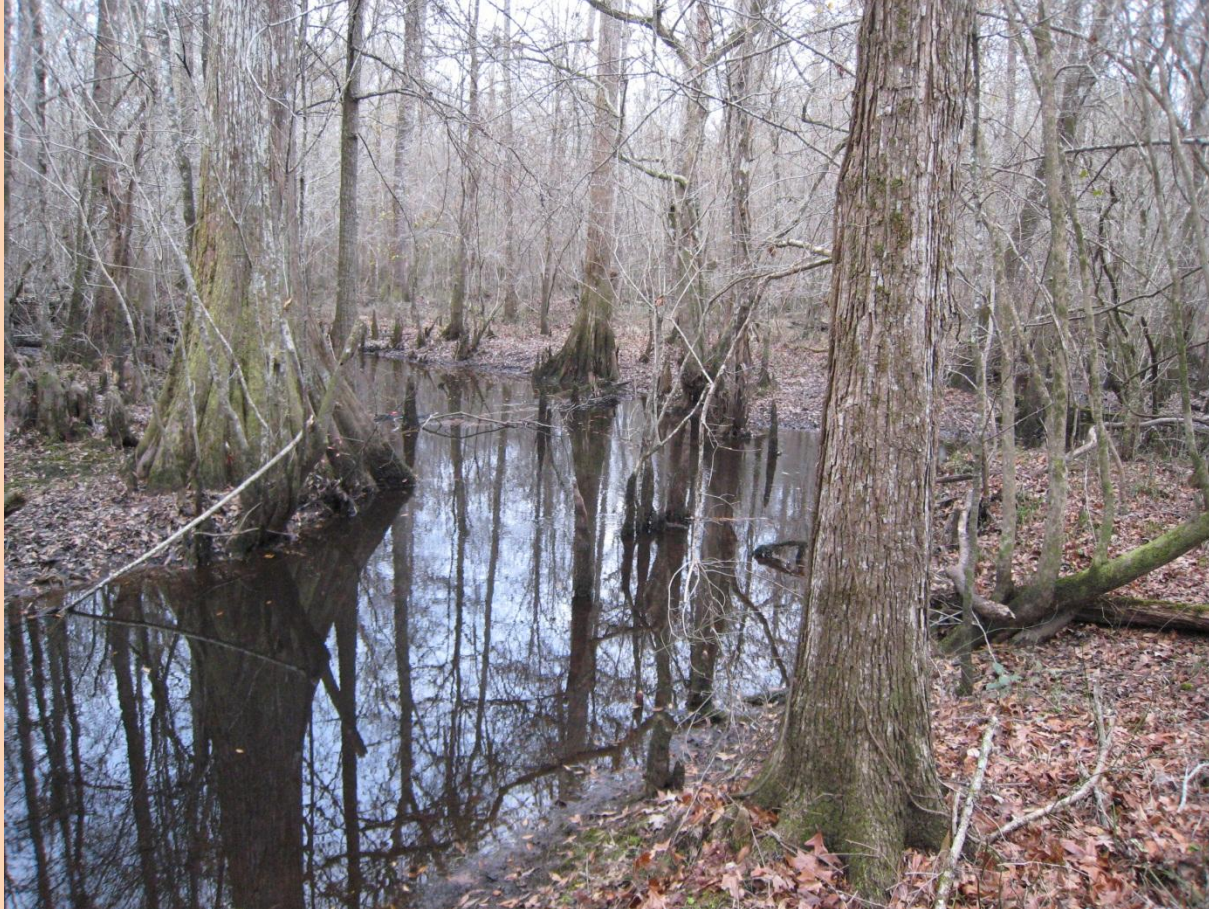
3. Riparian condition is not necessarily well known (However, generally good vegetation cover, limited ground disturbing activities, but with a legacy of hydrologic modifications and locally non-native invasive species such as feral hogs which add uncertainty).

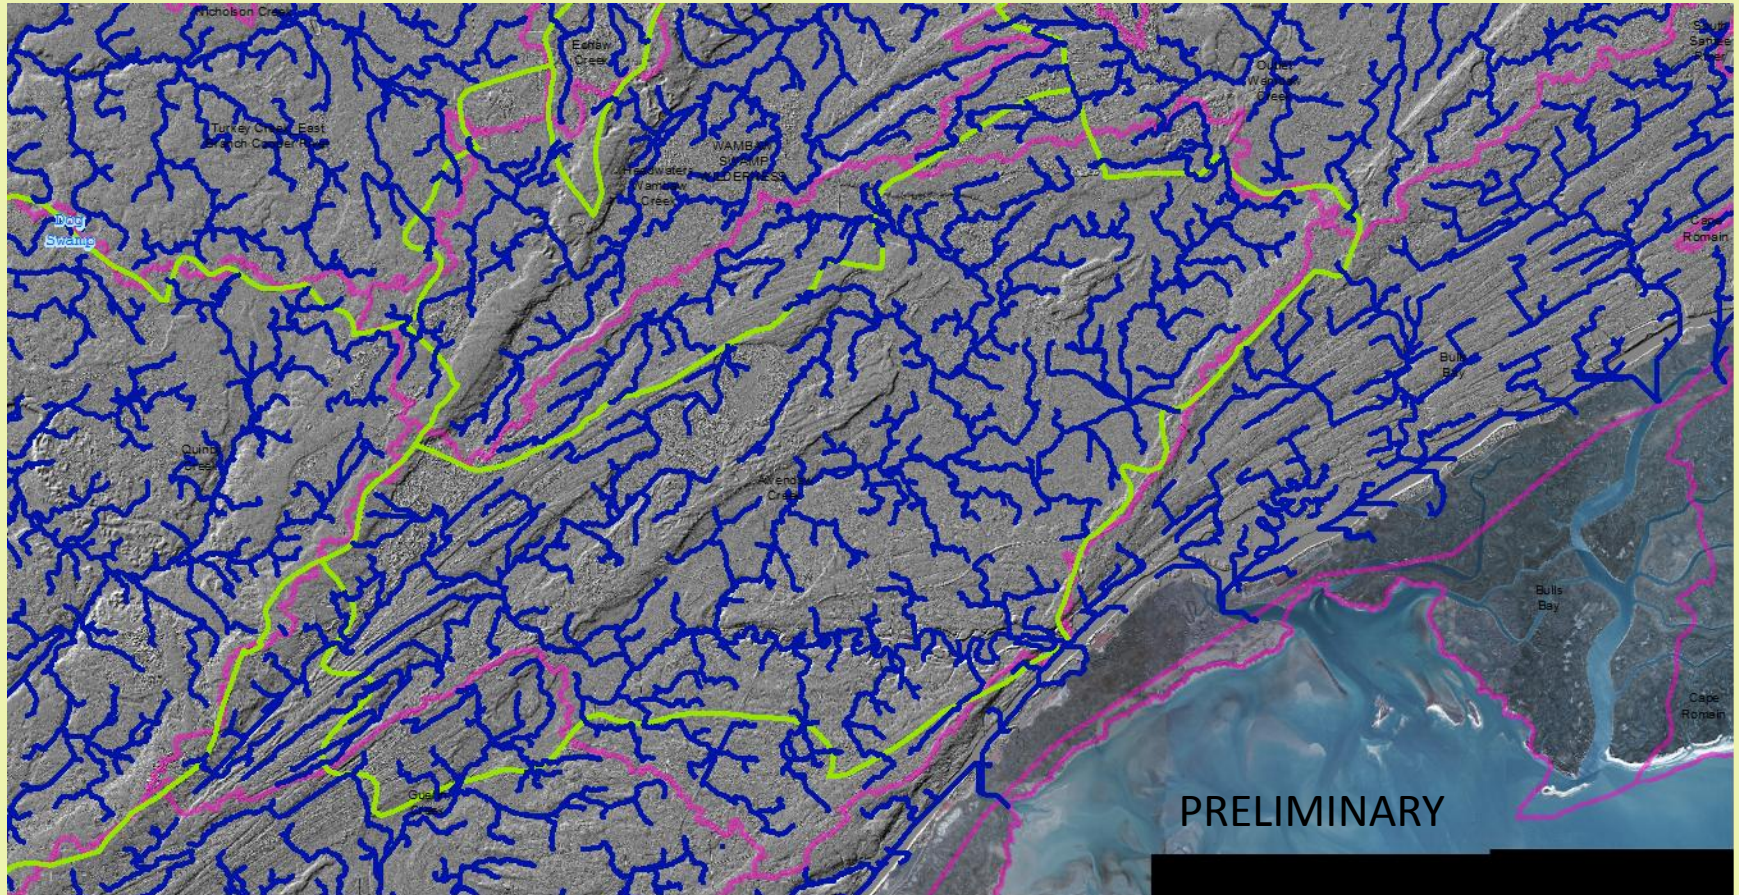
Awendaw Creek Subwatershed (current = 40 sq miles)

Estimated **Natural** stream network (blue) and subwatershed boundary (pink)
with roads and other barriers removed (Simon and Heyden, 2013).

NHD streams = 18 miles (not shown), Flow accumulation model streams 167 miles.

Green is Current WBD Boundary of Subwatershed.
